## Analysis of Environmental Conditions in the Andesite Mining Area of Kokap District, Kulon Progo Regency, Yogyakarta, Indonesia: Implications for Environmental Damage Prevention Monitoring

In this study, an analysis of environmental conditions in andesite mining areas was conducted as a form of monitoring in the prevention of environmental conditions. The methods used in this research are survey, mapping, and analysis methods using scoring that refers to the Decree of Gub. DIY Prop. No. 63 Year 2003. Field observations were conducted to find out information on environmental conditions and determine the areas to be mapped. While mapping is carried out using GPS (Global Position System) tools with medium accuracy of 3-5 meters that are stable. Based on the measurement results seen from the image map, it shows that it has a distance of less than 359.62 meters. The relief of the excavation base with a height tolerance of less than 1 meter, the slope of the excavation cliff with a tolerance reaching an angle of less than 18 degrees, the height of the excavation cliff with a height tolerance of less than 3 meters. The results of data processing and analysis of environmental damage tha

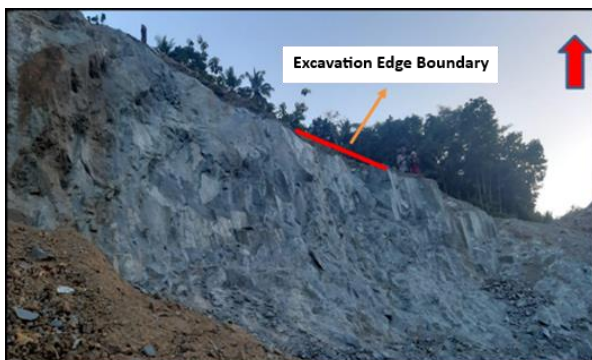
**Figure 2.** Documentation Excavated edge boundaries

Based on the results of the analysis, the environmental damage at the edge of the excavation in the field reached 4.7 meters. Documentation and measurements at the edge of the excavation can be seen in **Figure 2**. An excavation pit is a hole formed by mining excavated soil, while the depth of the excavation pit is the vertical distance from the Initial Land Surface to the field surface to the bottom of the excavation pit. The determination of the tolerable excavation depth limit for each land use is determined by the location of the groundwater table (Ibrahim, 2019; Luo et al, 2018; Umar Kura et al, 2013). The groundwater table is the boundary between the water-saturated soil layer and the water-unsaturated soil layer. The location of this layer varies depending on place and season. Lowlands generally have a shallow water table, while in higher areas the water table is deeper. During the rainy season, the water table is usually shallower than during the dry season. From the field measurements, the average depth of the excavation pit is 3 meters. This can be seen in **Figure 3**.

The edge of the excavation is the area between the outer limit of the excavation pit and the land around the mining area. From field measurements, the excavation edge of 4.7 meters has not met the requirements of the excavation edge limit according to the provisions, which is at least 5 meters. The distance between the edge of the excavation becomes a buffer area for the surrounding environment. If an avalanche occurs on an excavation cliff that has a narrow excavation edge, it will threaten the land and community facilities located close to the mining site. For this reason, technically, efforts can

be made to increase the distance of the edge of the excavation to a minimum of 5 meters and advise the community to stop digging on the cliff wall, which results in a smaller edge of the excavation.

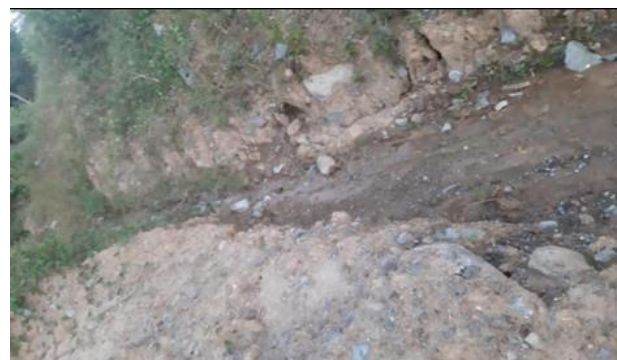
**Figure 3.** Documentation The boundary of the excavation depth from the initial soil surface

An excavation pit is a hole formed by mining, while the depth of an excavation pit is the vertical distance from the surface of the field to the bottom of the excavation pit. The determination of the tolerable excavation depth limit for each land use is determined by the location of the groundwater table. The groundwater table is the layer of soil that is saturated with water and the layer of soil that is not saturated with water. The measurement results in the field show that the limit to the pit varies because the mine site has been flooded and the measurement process must go down into the pit, starting from a depth of 3 meters above the highest water level, so it has good criteria, with a value of 1 based on the DIY Governor Decree No. 63 of 2003.

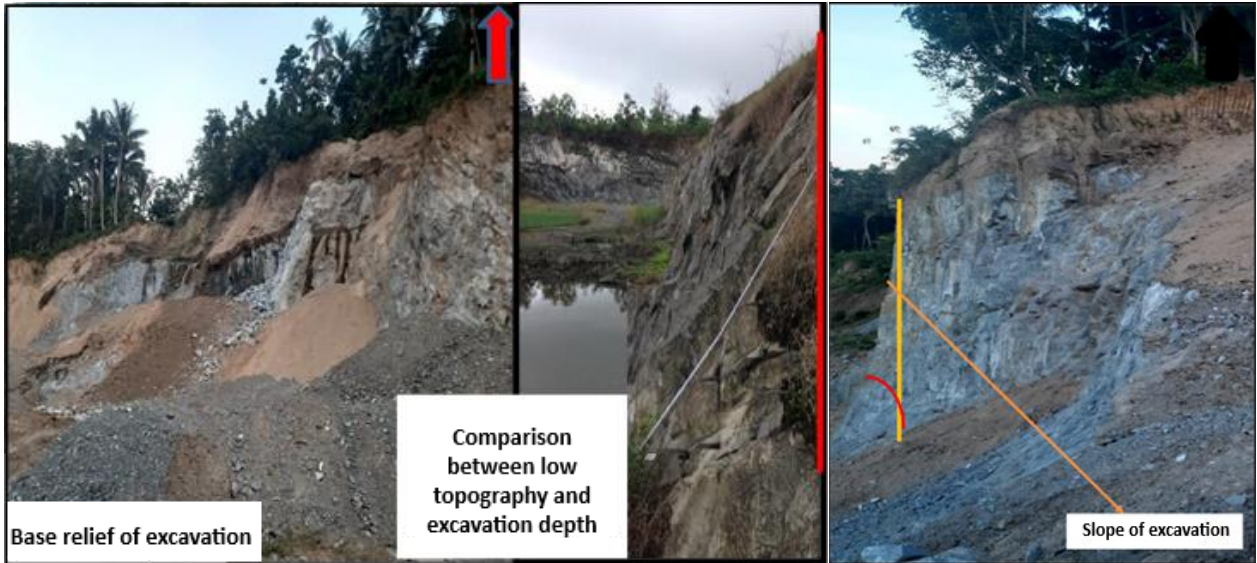
Figure 4. Documentation Relief of the excavated base

Based on the results of the environmental damage analysis, the base relief of the excavation in the field reached 2.4 meters. Measurement of the relief of the excavation base formed is carried out by measuring the distance between the ground surface around the bottom of the excavation and the pile of residual material at the mining site (Chen et al., 2021; Czinder & Török, 2021). The measurement method of the excavation base relief can be seen in Figure 4. In determining the slope of the excavated cliff slope, 2 measurement points were taken that represented the slope of the slope at the research location, then the slope value was averaged. Slope data obtained from measurements using a geological compass and GPS have units of degrees (o) which can be converted into percent (%) where a slope of 45 degrees equals 100%. Measurement of the slope of the excavated cliff was carried out as shown in Figure 5.

The relief of the excavation base is the difference between the depth of the excavation and the lowest topographic height in the vicinity (Meju & Le, 2002). The recommended excavation depth difference should be less than 1 meter; this is so that the depth of the excavation does not make it difficult for further land use or in accordance with its designation. Based on the results of observations and measurements made from the measurement points, the lowest excavation relief measurement ranges from 2- meters to 3- meters below the lowest surrounding topography, so the condition of the excavation relief is included in the classification of Damaged or with a grade/score of 3.

Mining activities with cliff slopes above 50% are very risky for landslides and can threaten the safety of miners. Based on the results of observations and measurements in the field, each slope of the excavation cliff at the point at the mining site was found to be a vertical slope condition. The measurement results obtained the average slope of the excavation cliff at 85° at the mining site; the slope of the cliff is >50% based on the Decree of the Governor of Yogyakarta No. 63 of 2003, so that the rating of this parameter is declared damaged or with a value/score of 3.

The condition of the excavated cliffs at the location of the former mining land has exceeded the tolerance limit, so there needs to be an arrangement of excavated cliffs that needs to be carried out with reference to existing provisions. Efforts to arrange the cliffs are carried out by setting the slope of the cliffs not to exceed 26.60 and the allowable cliff height of less than 3 meters. The repair of the excavated cliffs is carried out mechanically using heavy equipment used to work, namely the Backhoe. Based on observations, the height of the excavated cliffs reaches 10,995 meters. According to the existing provisions the height of the excavated cliffs is a maximum of 4 m. Therefore it is technically set to 2.9 m by forming cliff terraces such as bench terraces. The width of the terrace is at least 6 meters apart referring to Kep. Gub. DIY Prop. No. 63 of 2003. The boundary of the edge of the

Former mining land tends to be irregular and undulating due to the remnants of excavated material that is no longer being used. The remaining excavated material at the observation site that forms the relief of the excavation base, needs to be handled by placing it in a certain location so that it does not make it difficult when land use efforts are made. The arrangement of the relief of the excavated bottom is necessary to prepare a stable land for plant planting activities. From field measurements, the relief of the excavation base formed varies between 1 meter and 2.4 meters. Most of the remaining excavated material is in the form of large chunks of rock. With the creation of a cliff terrace, it will reduce the height and slope of the excavated cliff, which is able to reduce the speed and volume of surface flow and also allow more water to be infiltrated, so that damage can be minimized. In the next observation, damage occurred to the road condition, The road condition observed has a hollow condition with a hole distribution area of >30% from before there was mining, but the road is still accessible, but this must be repaired in order to reduce the damage that has occurred, referring to Kep. Gub. Prop. DIY No. 63 of 2003 that road conditions must be improved so that road conditions are not hollow and bumpy. The point of this improvement recommendation will help in repairing the environmental damage that has occurred, here is an assessment of the results of the recommendations for improving the level of physical environmental damage due to mining of andesite commodities which can be seen in **Table 4**.

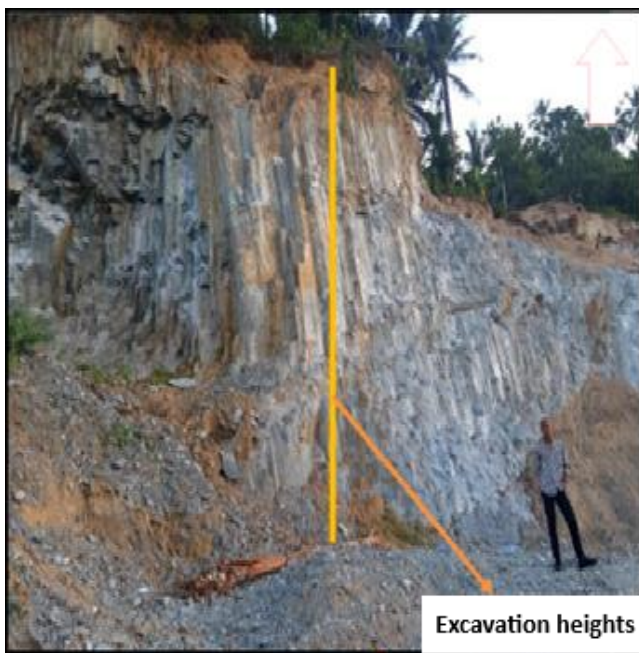
Figure 6. Documentation Excavation wall height

Based on the results of the environmental damage analysis, the height of the cliff excavated in the field shows that it reaches (7-8) meters. Measurement of slope height using the trigonometric equation in **Figure 6**. Measurement of cliff height in the field can be done in 2 ways. Firstly, if the slope is steep, the measurement can be done directly from the bottom of the excavation (toe) to the top of the cliff (crest) (Mustofa et al., 2024; Pérez-Labrada et al., 2024). Second, if the slope is relatively gentle. The road used to bring material from the mine site to order is deliberately made for smooth transport. The condition of the road needs to be considered because it involves the risk of road damage. Road conditions at the mine site, both from the mine entrance to the road in the mine, have moderate criteria, with a distribution area of < 30% on the road in the mine, so that the mine entrance road is only bumpy. Documentation of road conditions can be seen in **Figure 7**. The results of the analysis of environmental damage at a distance from bridges and river buildings in the field reached 359.62 meters. for road condition documentation can be seen in **Figure 8**.

The height of the excavation wall is the edge of the excavation hole as a whole from the surface to the bottom of the hole. To maintain the stability of the excavation wall, it should be tiered to prevent landslides. The height of the excavation wall was measured by using a meter. Based on the measurement results from fifteen points in the mining location, the result of the excavation wall height has a value of 10.995 meters. Giving a score of 3, based on the Decree of the Governor of Yogyakarta in 2003, the height of the excavation wall at the mining site is damaged.

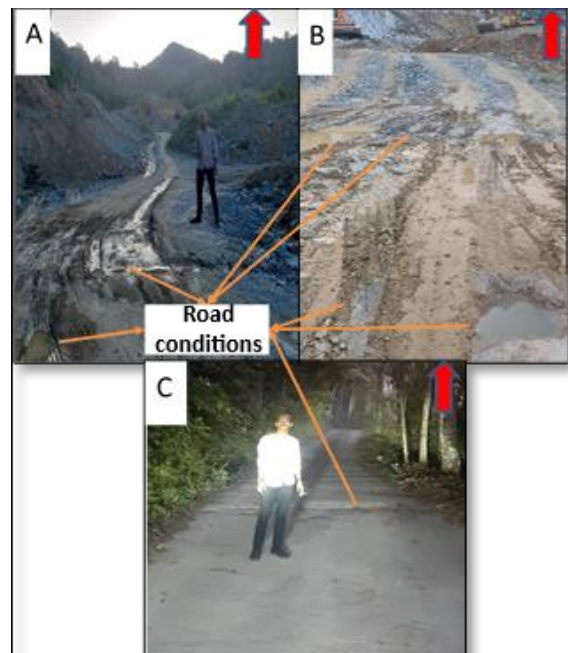
Figure 7. Documentation Conditions A) Mine driveway, B) mine inner road, C) mine outer road

Roads are very important infrastructure for smooth travelling, both using motorbikes and cars. While at the mine site, roads are also very important for mobilizing vehicles to transport excavated materials at the mine site to be marketed. From the observations in the field, the mine road is not asphalted and uses the soil at the mine site itself to be stockpiled and used as a mine road. The road conditions at the mine site are slightly bumpy and do not endanger the drivers themselves. So that the road conditions at the mine site are still included in the medium benchmark, or score 2.

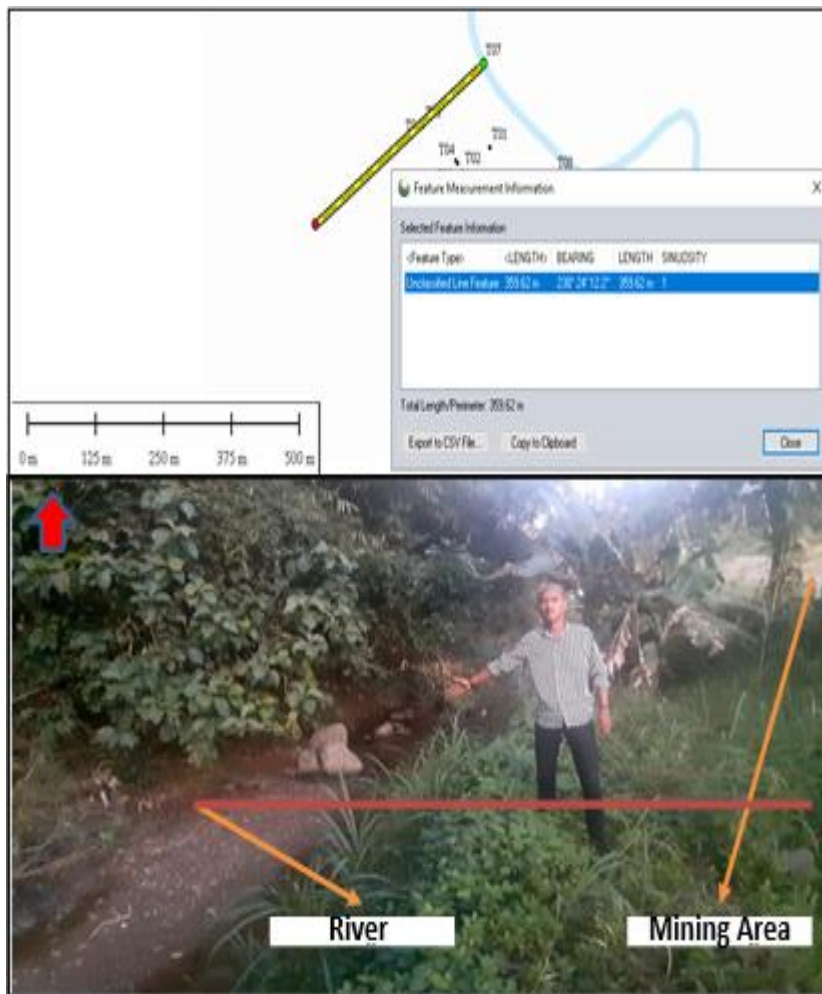
**Figure 8.** Documentation Distance from bridges and river buildings

Distance from bridges and river buildings upstream is a measure of length (meters) between the outermost point and the nearest point of the upstream boundary. Measurements are made by measuring the distance from the mine pit to bridges and river buildings; the distance from bridges and river buildings upstream is recommended at a minimum if the distance is >500 m upstream and >1000 m downstream from the bridge/river building. Based on the measurement results seen from the image map, it shows that it has a distance of less than 359.62 meters from the mining site. This means that the value is moderate and/or with a value/score of 2.
