The Relationship of Physical Properties of Rock to The Slope Stability of The Progo River Cliff in Sentolo-Sedayu, Kulon Progo, Yogyakarta, Indonesia

To support the increasingly advanced development of the Kulon Progo area, road access via the Progo River bridge needs to be maintained in instability. To support this, an engineering geological survey was carried out to find out the relationship between the physical properties of rocks and the stability of slopes on the cliffs of the Progo River. The research method begins with a field survey to obtain lithology and slope geometry data. Scanlines at selected locations were carried out to determine discontinuity areas and interpret rock weathering using a Schmidt hammer. Physical laboratory tests are useful for determining the bulk density and porosity of rocks, while from rock mechanical tests (shear strength) cohesion and friction angle values are obtained. The results of the safety factor analysis using the Slide program show that the slopes generally have a medium-high level of severity ($F_k < 1.2$), supported by quite a lot of joint areas, varying porosity (4.12 – 25.10%) and the level of weathering is at level III-IV. Rock por

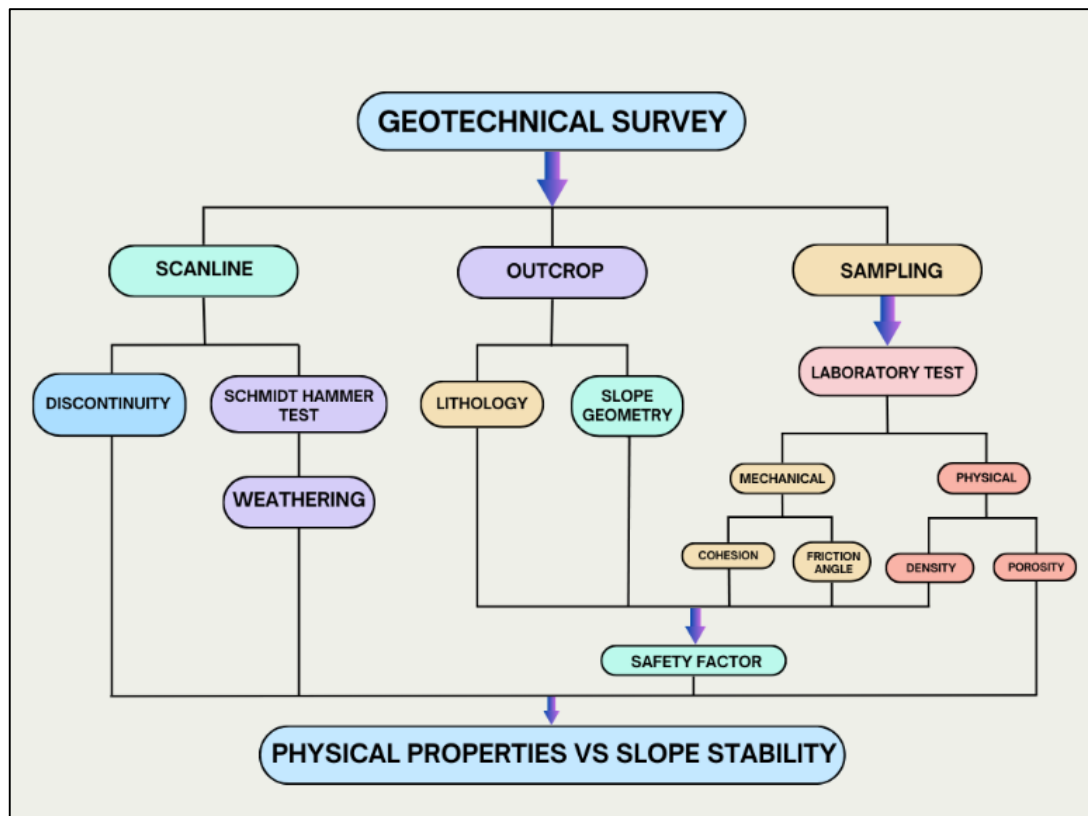
Figure 2. Flow diagram of research method.e

Geotechnical aspects are the main study in this survey (**Figure 2**). This geotechnical survey was carried out by observing slopes, measuring discontinuity areas using the scanline method, and equipped with rock sampling. Slope data includes the constituent lithology and slope geometry. Data collection on discontinuity areas was also accompanied by measuring the reflection value (R) using a Schmidt hammer (Hirose et al., 2008). This reflectance value is then used to interpret the level of rock weathering. Data collection on discontinuity areas includes, among other things, number, type, position, persistence, roughness, and infilling of discontinuity areas.

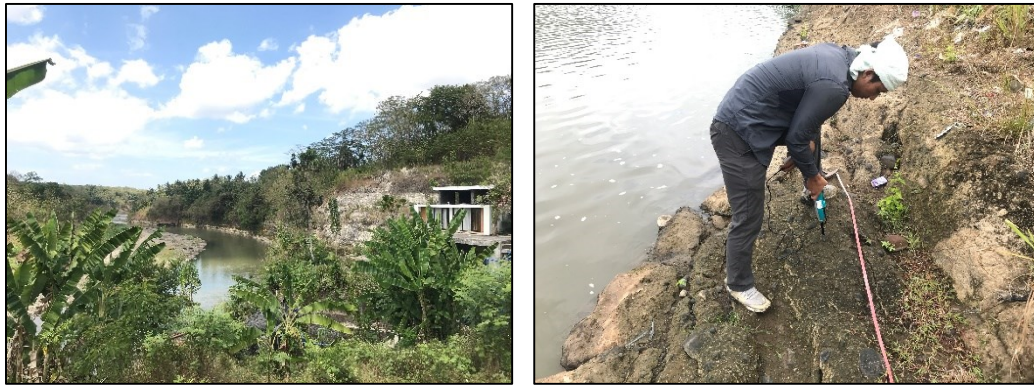
Figure 3. Slope composed of calcarenite at location Sc. 2 (left) and andesite breccia at location Sc. 6 (right).

Slope measurements were carried out with a scanline at eight points, namely at Sc. 1 – Sc. 8. The Slope at points Sc. 01 and Sc. 02 (Figure 3) is composed of layered limestone (calcarenite), while in the other six locations it is composed of andesite breccia. Calcarenite is a Tertiary sedimentary rock from the Sentolo Formation, which is compact and hard, with thin – medium layers. Meanwhile, andesite breccia generally has a massive structure. On all slopes studied, the rocks show a considerable amount of joints.

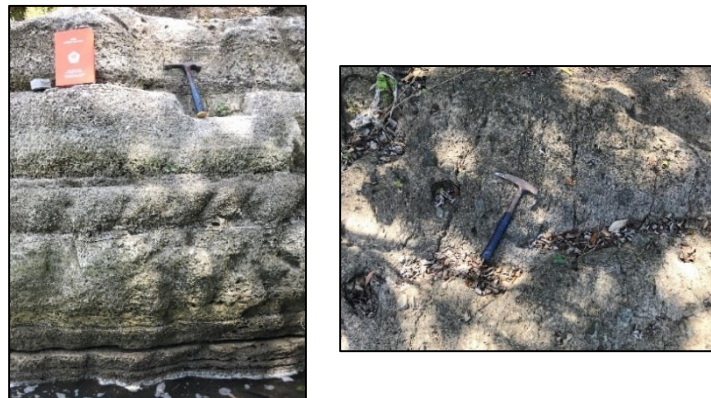
Figure 4. The discontinuity area in calcarenite (Sc. 2) is in the form of layers and joints (left), while in andesite breccia (Sc. 8) it is dominated by joints (right).

An example of the results of data collection on discontinuity areas is presented in **Table 1** and **Table 2**. Slopes on calcarenite limestone have discontinuities in the form of layers and joints, while slopes on andesite breccia rocks only have joints. The joint areas found are generally not persistent, open (openings 2-50 mm), with sand infilling (Li et al., 2018; Togibasa et al., 2018).

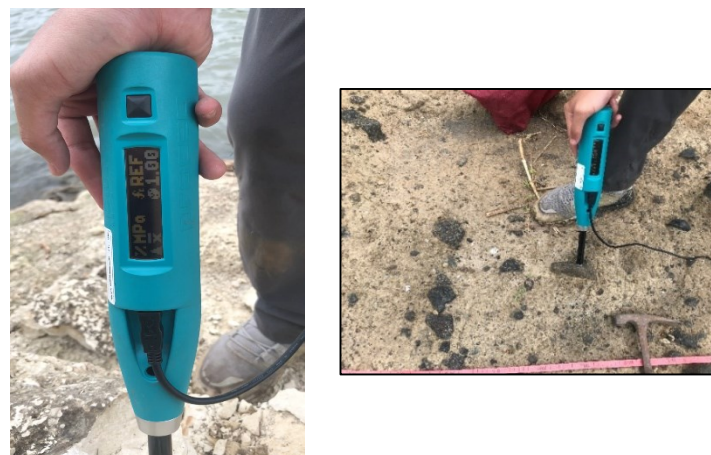
Figure 5. Example of measuring rock strength using a Schmidt hammer on calcarenite at the Sc location. 1 (left) and in andesite breccia at location Sc. 6 (right).

The data on the strength of the slope rocks based on the Schmidt hammer test shows that the R-value varies. Examples of rock strength data can be seen in **Table 3**. From this data, rock weathering conditions can be determined by referring to Brindha & Elango, (2012) and Orwin, (1998) classification. Based on this classification, it is known that the rocks that make up the slopes, whether in the form of calcarenite or andesite breccia, have varying degrees of weathering (class I – IV), with weathering stages from fresh to weakened rock (**Table 4**). For the four samples selected for laboratory tests, the average R-value was used to analyze the relationship between weathering and slope strength (**Table 5**).

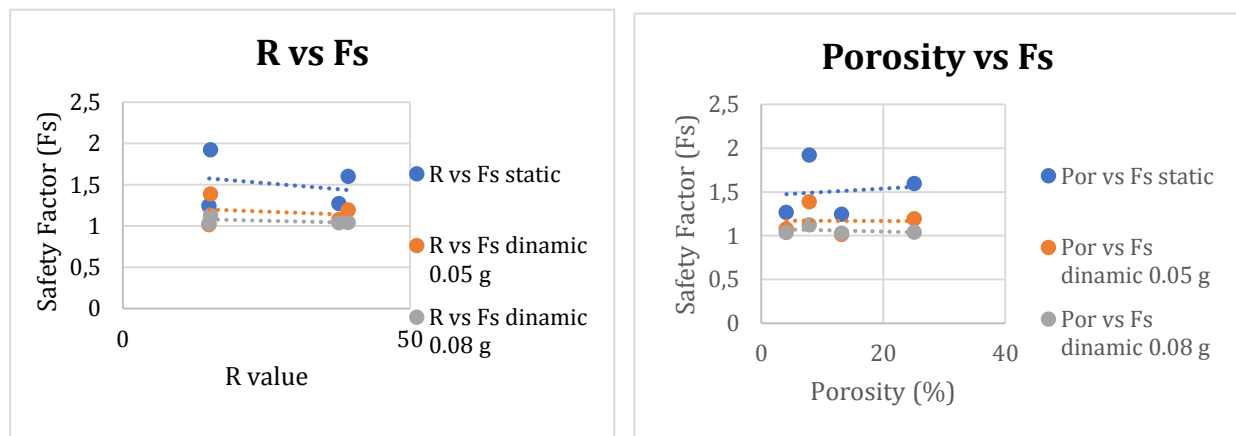
Figure 5. The relationship between weathering and rock porosity and slope safety factors.

The data in **Table 5** is then processed using a linear regression graph as shown in **Figure 5**. From this graph, it appears that the slope safety factor tends to decrease with increasing rock weathering, where this condition is more clearly visible in static conditions. The correlation graph between the two variables is not very clear, perhaps because the rock samples on the andesite breccia slopes are only represented by rock fragments in the form of andesite. These andesite breccia fragments were found fresh to slightly weathered. Meanwhile, the breccia matrix is generally more weathered, and sometimes it has even turned into soil.

The relationship between porosity and slope safety factor is relatively stable. In dynamic conditions where the slope receives a seismic load of 0.05 g or 0.08 g, an increase in porosity results in a decrease in the safety factor. However, in static conditions, an increase in porosity is accompanied by an increase in the safety factor. This anomaly occurs because the porosity of calcarenite is quite large, and seems to be less comparable to andesite igneous rocks. Under static conditions, an increase in porosity is not always accompanied by a decrease in the safety factor. The difference in relationships in static and dynamic conditions shows that the relationship between porosity and safety factors is not strong. This means that slope stability is less correlated with the porosity of the rocks that make up the slope.
